# TECHNICAL MATTERS

APRIL 2006

Issue 1

Welcome to the first issue of *Technical Matters*, a publication containing a series of case studies covering technical problems and their solutions, produced by Lloyd's Register EMEA's Technical Investigations.

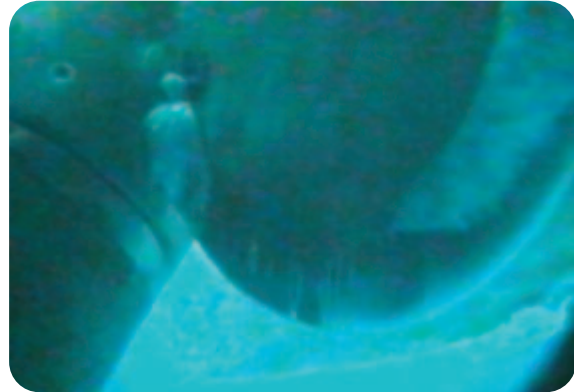
Figure 1

The problem was identified as originating in the angle of attack variations at the blade roots due to the propeller shaft's inclination. **Figure 1** shows the full-scale cavitation on the propeller blades when operating at high speed as observed through windows in the hull. Of interest is the cavitating structure at the trailing edge of the root cavity which was in the root erosion region.

The video images showed that due to the high pitch ratio of the blades, in excess of 1.7, this conventional approach did not allow sufficient air to be held in the cavities and hence could not fully cushion the cavity collapse process, producing the erosion damage.

An air injection system was devised based on previous successful experience by Lloyd's Register's Technical Investigations. This proved to be moderately successful in that it allowed the vessel to enter restricted service while a more permanent solution was found. Full-scale observation of the air injection process on the ship provided key information for a subsequent series of model tests.

Model tests were used to develop an alternative air supply configuration and machined holes in the blade roots at approximately the one-third and two-third chord positions at the 0.3R radius. Through an iterative process, a suitable air-flow rate was determined such that a minimum speed loss was achieved while maintaining intact stencil ink coatings on the model blades, which were used to assess the tendency to cavitation erosion.

The machined holes in the blade roots appeared to delay the onset of erosion and increased the speed at which air injection would need to be started. In addition, the holes provided a mechanism by which air could transfer from the pressure side to the suction side and ensured that air was resident in the root cavities for a substantial part of each blade revolution.

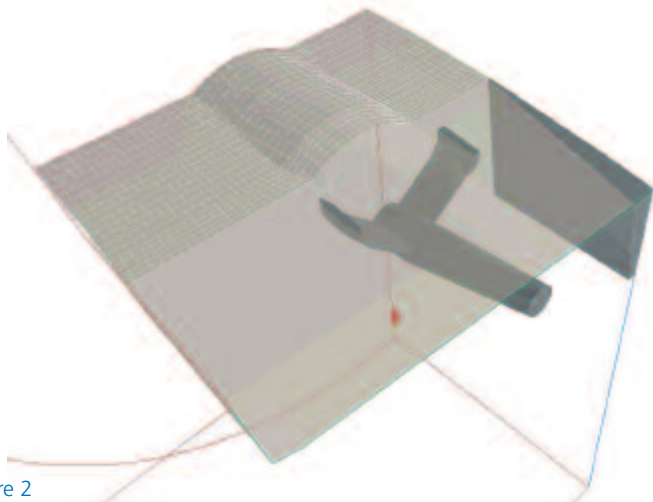
Figure 2

Because of the scaling complexities of using model tests to understand the flow field around the A brackets, the flow field was analysed using a computational fluid dynamics (CFD) code in combination with Technical Investigations' propeller analysis codes. **Figure 2** shows a view of the solid body representation and a part of the computational grid used in the simulation model.

The simulations showed that the A brackets were contributing significantly to the wake field disturbance and could be better aligned to the local flow directions. However, to achieve such an alignment would have required the vessel's twin-screw shafting system to be mechanically re-aligned, which the shipbuilder was reluctant to undertake if other methods could be developed to solve the flow problem. A compromise was achieved by re-adjusting the leading and trailing edge shapes to form an S-shaped cross-section of the A bracket. The system was then re-analysed with the modified bracket geometry in order to confirm improvements. Contours of velocity ratio at several planes downstream from the brackets allowed the quality of the axial wake entering the propeller plane to be assessed.

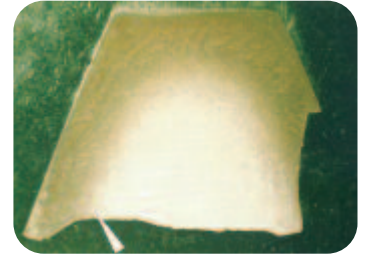
Figure 5a

Fatigue cracks which lead to tooth breakages invariably originate on the tooth root surface or on the flank in areas of pitting and exfoliation damage. The isolated single-tooth failures shown in **Figures 5a and 5b** are less common where fatigue cracks have grown from sub-surface origins. In both cases, cracks were initiated close to the transition between the core material and the carburised case - a position where the expected residual stresses would be tensile. Other similarities included an absence of metallurgical defects and a heat treatment procedure which resulted in a satisfactory case depth hardness profile and distribution of carbides.

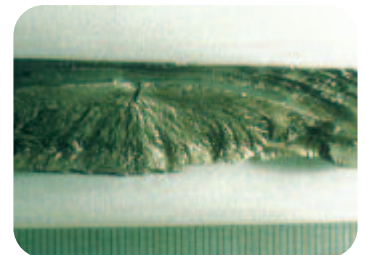
Figure 5b

The failure shown in **Figure 5c** could be easily explained by the remaining evidence of debris that had been entrained in the mesh. This was found as a small accretion of steel cold welded to the tooth flank in the area of the sub-surface crack origin. The chemical composition of the alloy confirmed that it was a foreign body. Conversely, the similar single-tooth fracture of a different propulsion pinion remains unexplained; all the more so because the crack origins were some one-third of the face width distant from the end of the tooth, as shown in **Figure 5b**.

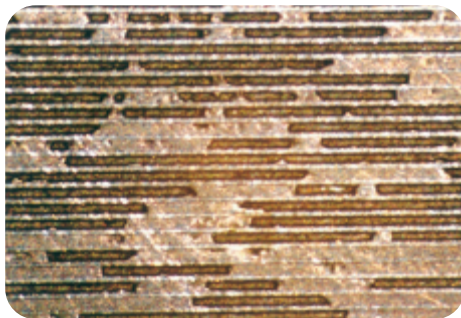
Figure 6

The 'Rillenlager'-type bearing was designed to counteract overlay-wear problems for engines burning residual fuels; **Figure 6**. Fatigue cracking and consequent premature loss of the overlay from the grooves of such bearings have been found in a connecting rod application, **Figure 7**, which required a stronger but harder overlay material.

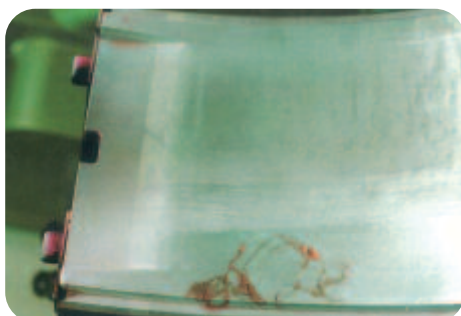
Figure 8

and the steel backing shell has failed. Engineers should also be aware of the importance of the material microstructure in terms of the distribution and grain size of the respective alloy phases. In addition to fatigue cracks, **Figure 8** illustrates a mottled surface appearance caused by thermal ratcheting of a poorly cast tin-based alloy.

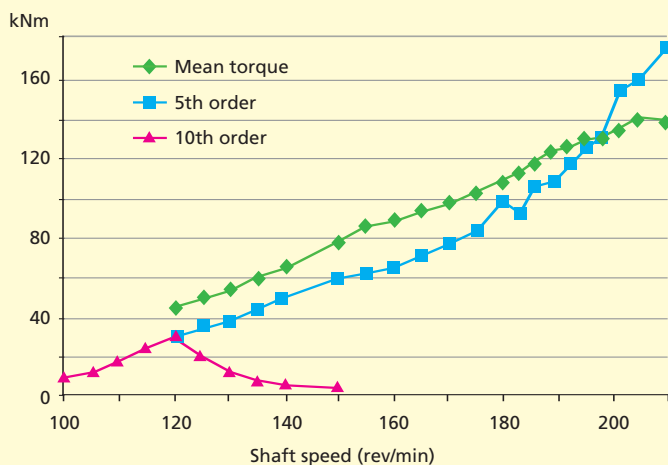
Figure 9

Furthermore, vibratory torques which were measured in the intermediate shaft exceeded the mean torque at higher shaft speeds, as seen in **Figure 9**. Associated with these vibratory torques was a corresponding increase in axial vibration of the intermediate shaft.

A one-node, tenth-order torsional vibration critical speed was measured at 130 rpm, indicating that the corresponding one-node, fifth-order critical frequency would occur at 260 rpm. This speed was only 24% above the main engine speed of 210 rpm and compared with a critical speed of 284 rpm calculated by the engine builders. Consequently, vibratory stresses and torques were larger than predicted as the operating point was further up the flank of the resonant response curve.

It was recommended that global vibration of the ship could be reduced by either a re-tuning of the shafting torsional vibration characteristics which would entail the installation of a torsional damper, a change of shafting and possibly a barred speed range or, alternatively, the installation of an electrically driven, independently mounted, fifth-order thrust compensator. The vessel's owners elected to adopt the latter recommendation and the modification was implemented. Subsequent vibration measurements indicated that vibration levels throughout the vessel had fallen to a level below those where complaints regarding habitability were likely as seen by **Figure 10**.

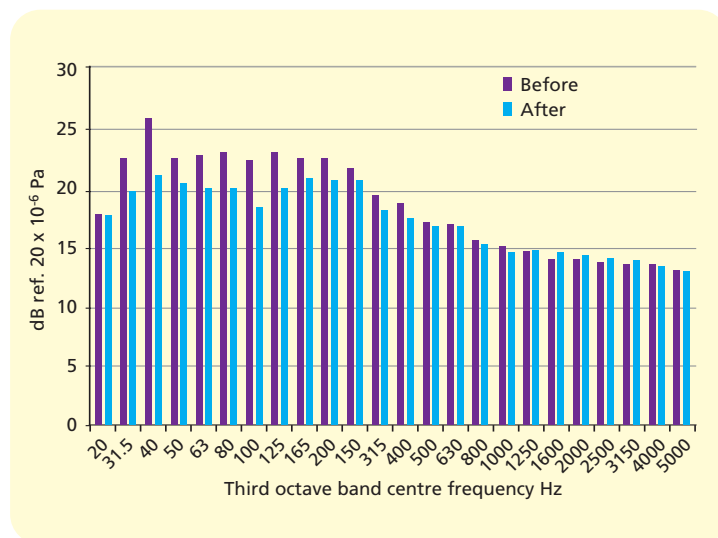
Figure 11

The source of the tonal noise was identified as exhaust gas pulses from the four diesel generators exiting the funnel, with the frequency of the pulses corresponding to the firing frequency of the six-cylinder, four-stroke diesel engines. Pressure measurements on the inlet and outlet sides of the installed exhaust gas silencers showed that frequency components less than 50 Hz were not attenuated effectively by the silencers.

The measurement and calculation results were then used by a silencer manufacturer to design a secondary silencer and these were fitted in each of the four exhaust trunkings. Follow-up measurements confirmed a significant reduction in low frequency noise components, **Figure 11**.

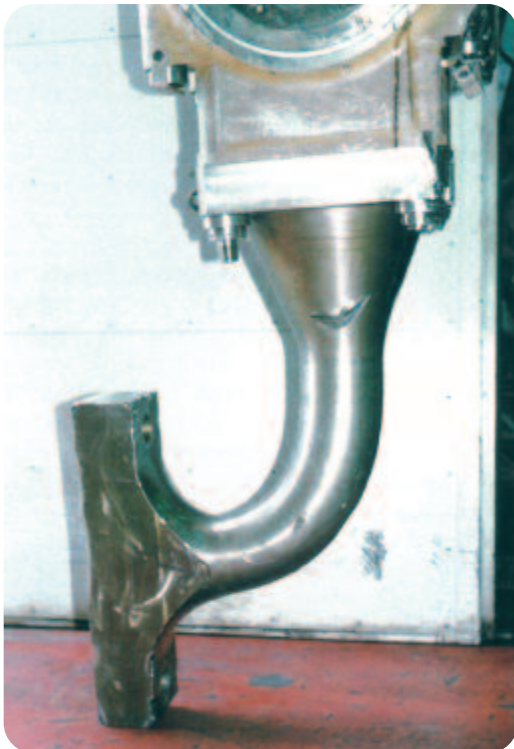
Figure 12

The engine which suffered damage was an eight-cylinder two-stroke marine diesel engine arranged to drive a large alternator. The first indications that it had a problem were loud knocking sounds. Unfortunately, before the engine could be brought to a stop, one of its connecting rods separated from the crank pin and emerged from the crankcase, causing substantial damage. The final state of the connecting rod can be judged from **Figure 12**.

As the various damaged parts became accessible, possible alternative causes were tested for credibility. By this process, attention was increasingly drawn to the need to find the crank bearing bolts, which were not initially accessible. When they were retrieved, one of them was found to be virtually intact, but without its nut. This nut, its locking device and locking screw were all found separately. The nut threads for about one and a half turns nearest to the lower face were seen to have been damaged by axial shear.

About one quarter of the first turn, although present, had been separated from the nut around its circumference. The other bolt had broken under severe combined tensile and bending load and its nut, with locking device and screw, was still present on the broken end. Furthermore, a bolt in a different connecting rod was found to be 1 mm slack, with its nut locking device and locking screws correctly fitted.

This evidence clearly showed that the slackening and loss of the intact bolt was the initiating cause of the engine damage. In searching for the reason why the bolt became slack, the effects on the bolt of possible cylinder malfunctions were calculated and physical tests of similar bolts were conducted. The key finding from this work was that if the bolt had been properly tightened, the probability that sufficient torque could have been generated to loosen the nut against the frictional resistance of the threads and of the nut face was minimal. The torque due to tensile load, which normally acts to unscrew a nut, was found to be one eighth of the frictional torque resisting such movement. It was concluded, therefore, that the damage resulted because the bolt had not been properly tightened to the correct tensile load.
