# TECHNICAL MATTERS

APRIL 2006

Issue 1

Welcome to the first issue of *Technical Matters*, a publication containing a series of case studies covering technical problems and their solutions, produced by Lloyd's Register EMEA's Technical Investigations.

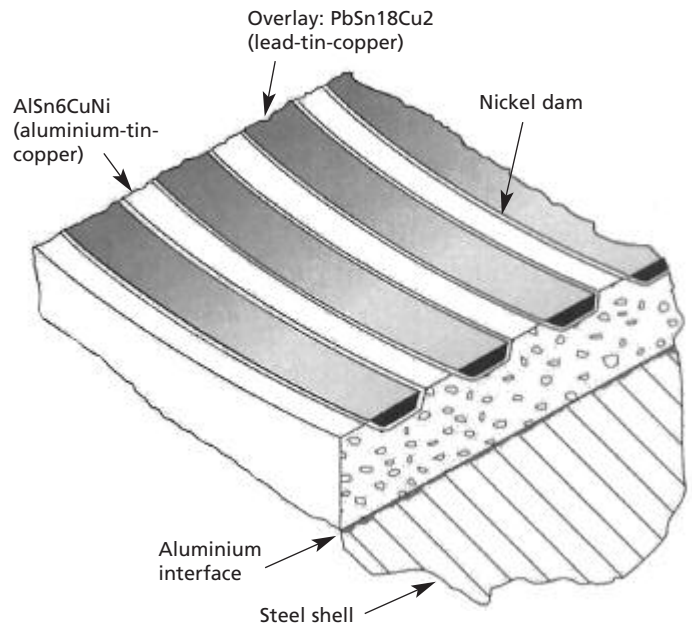
Figure 6

The 'Rillenlager'-type bearing was designed to counteract overlay-wear problems for engines burning residual fuels; **Figure 6**. Fatigue cracking and consequent premature loss of the overlay from the grooves of such bearings have been found in a connecting rod application, **Figure 7**, which required a stronger but harder overlay material.
